# **NATIONAL TRANSPORTATION SAFETY BOARD**

## **RAILROAD ACCIDENT REPORT**

**FIRE ONBOARD AMTRAK PASSENGER TRAIN  
TRAIN NO. 11, COAST STARLIGHT  
GIBSON, CALIFORNIA  
JUNE 23, 1982**

NTSB / RAR-83 / 03

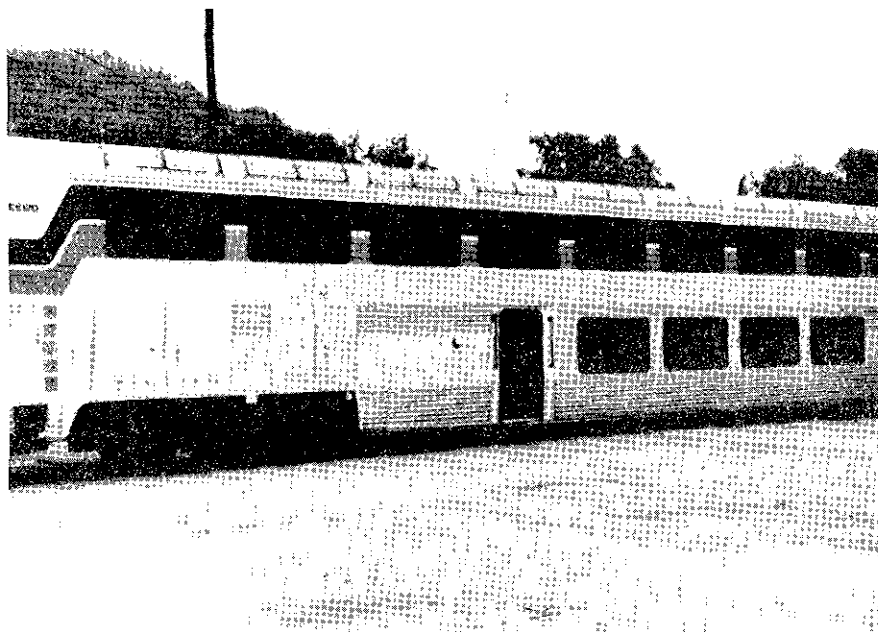
Figure 1.--Amtrak superliner sleeping car.

As the 1130 car attendant moved toward the 1131 car at the rear of the train, she met the rear brakeman coming forward through the end door of the car. She told him about the fire, and he radioed the conductor to stop the train saying, "We have a fire back here." Shortly afterward, the rear brakeman again radioed the conductor saying, "This fire is pretty big; we'd better stop." The rear brakeman continued toward the front of the 1130 car, knocking on doors and shouting, "Fire." The 1130 car attendant continued toward the rear of the 1130 car, exited through the car's upper level end doors, and proceeded down to the lower level of the 1131 car to awaken the 1131 car attendant, who was taking her rest period in bedroom No. 14. By that time, the train had been stopped, and the 1130 car attendant detrained from the right vestibule door of the car 1131. (See figure 1.)

When the 1130 car attendant and the rear brakeman became aware that a handicapped passenger was still in bedroom A on the upper level of the 1131 car, they climbed up the rear of the car to the upper level and attempted to enter the car through the upper level end door to rescue the passenger. The end car door, which was also the end of the train, had been locked with a key to prevent its opening by passengers. The rear brakeman could not open the door until he had been provided with a coach key. When the door was opened, volumes of thick black smoke immediately emptied through the door, thus, preventing their entry into the car. They discovered later that because the cars were oriented in the train such that the deluxe bedrooms were adjacent to each other, the handicapped passenger had to be reached from the front end of the car. (See figure 1.)

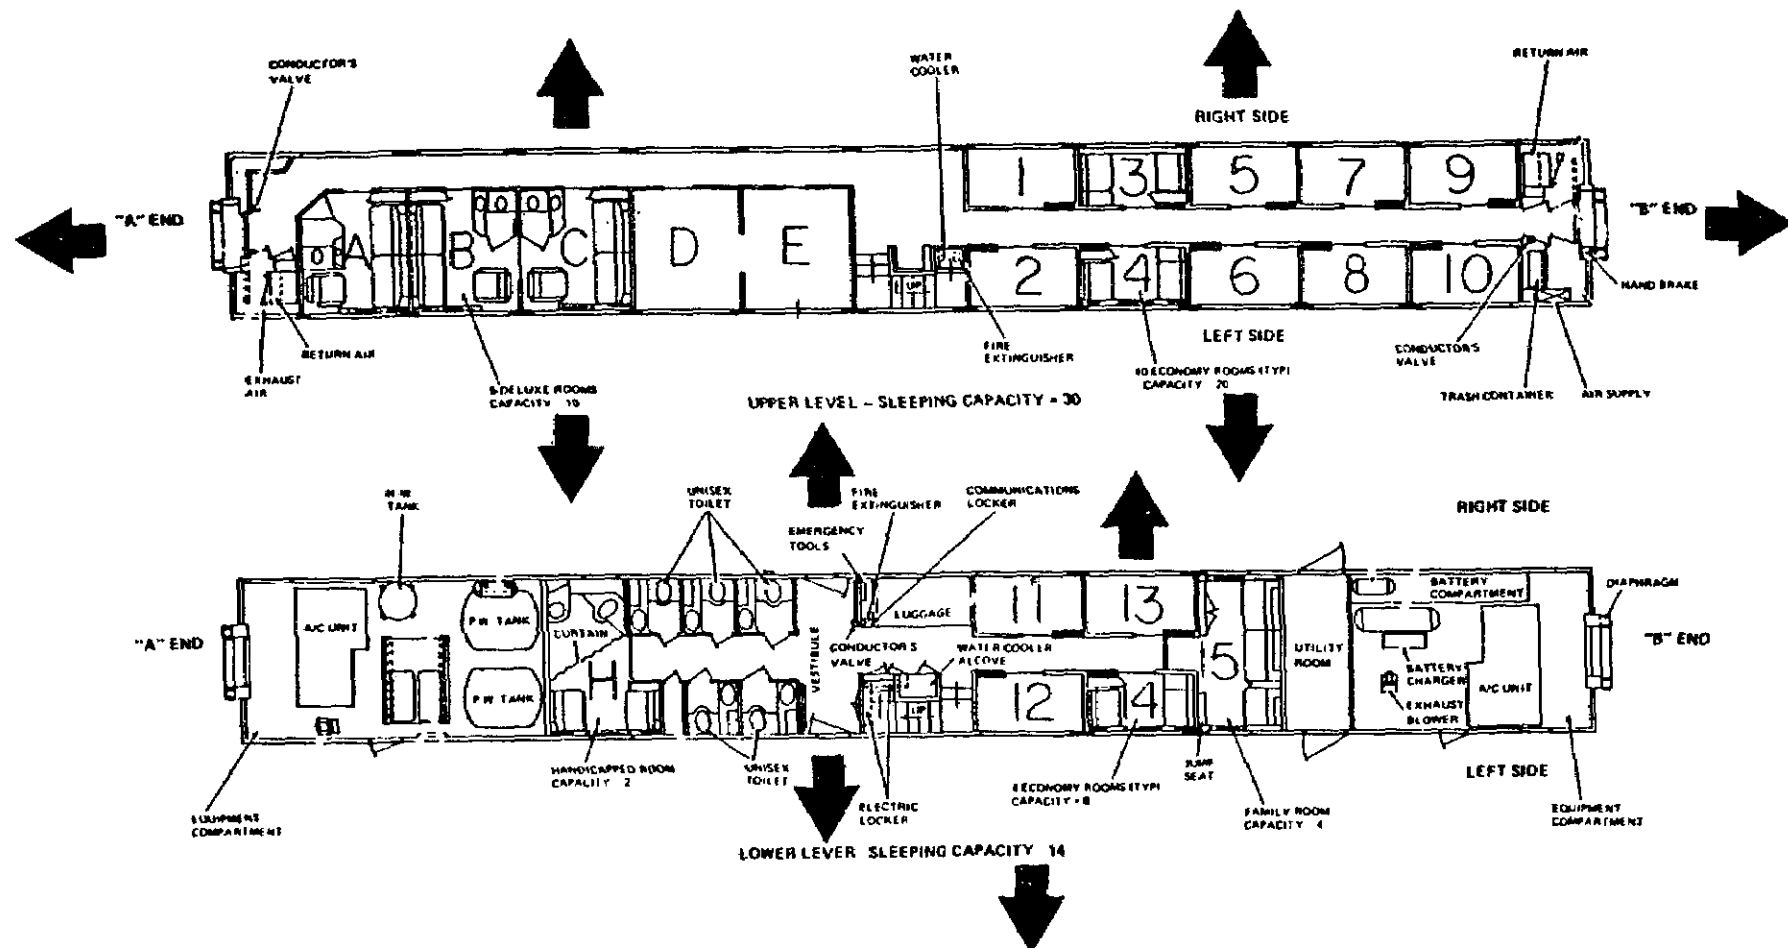
Figure 2.--Typical interior arrangement of the 1130 and 1131 sleeping cars.

NOTE. Arrows indicate location of emergency exit windows and doors.

Car Arrangement.--The superliner sleeping car consisted of economy (see figure 9) and deluxe bedrooms. The economy bedrooms were identified numerically and the deluxe bedrooms were identified alphabetically. (See figure 2.) Thirty passengers could be accommodated on the upper level of the car. A handicapped bedroom, equipped with appropriate facilities, a family bedroom, and four economy bedrooms were located on the lower level, which could accommodate 14 passengers. Five unisex restrooms for the economy bedroom passengers were also located on the lower level. The entrance to each bedroom was provided with a full-length curtain and a sliding door which contained a glass window and a door lock. The bedroom door could be locked only from the inside. To open a locked bedroom door from the outside, a phillips-type screwdriver must be used to remove screws holding a coverplate over the lock, and then a standard coach key can be inserted to unlock the door.

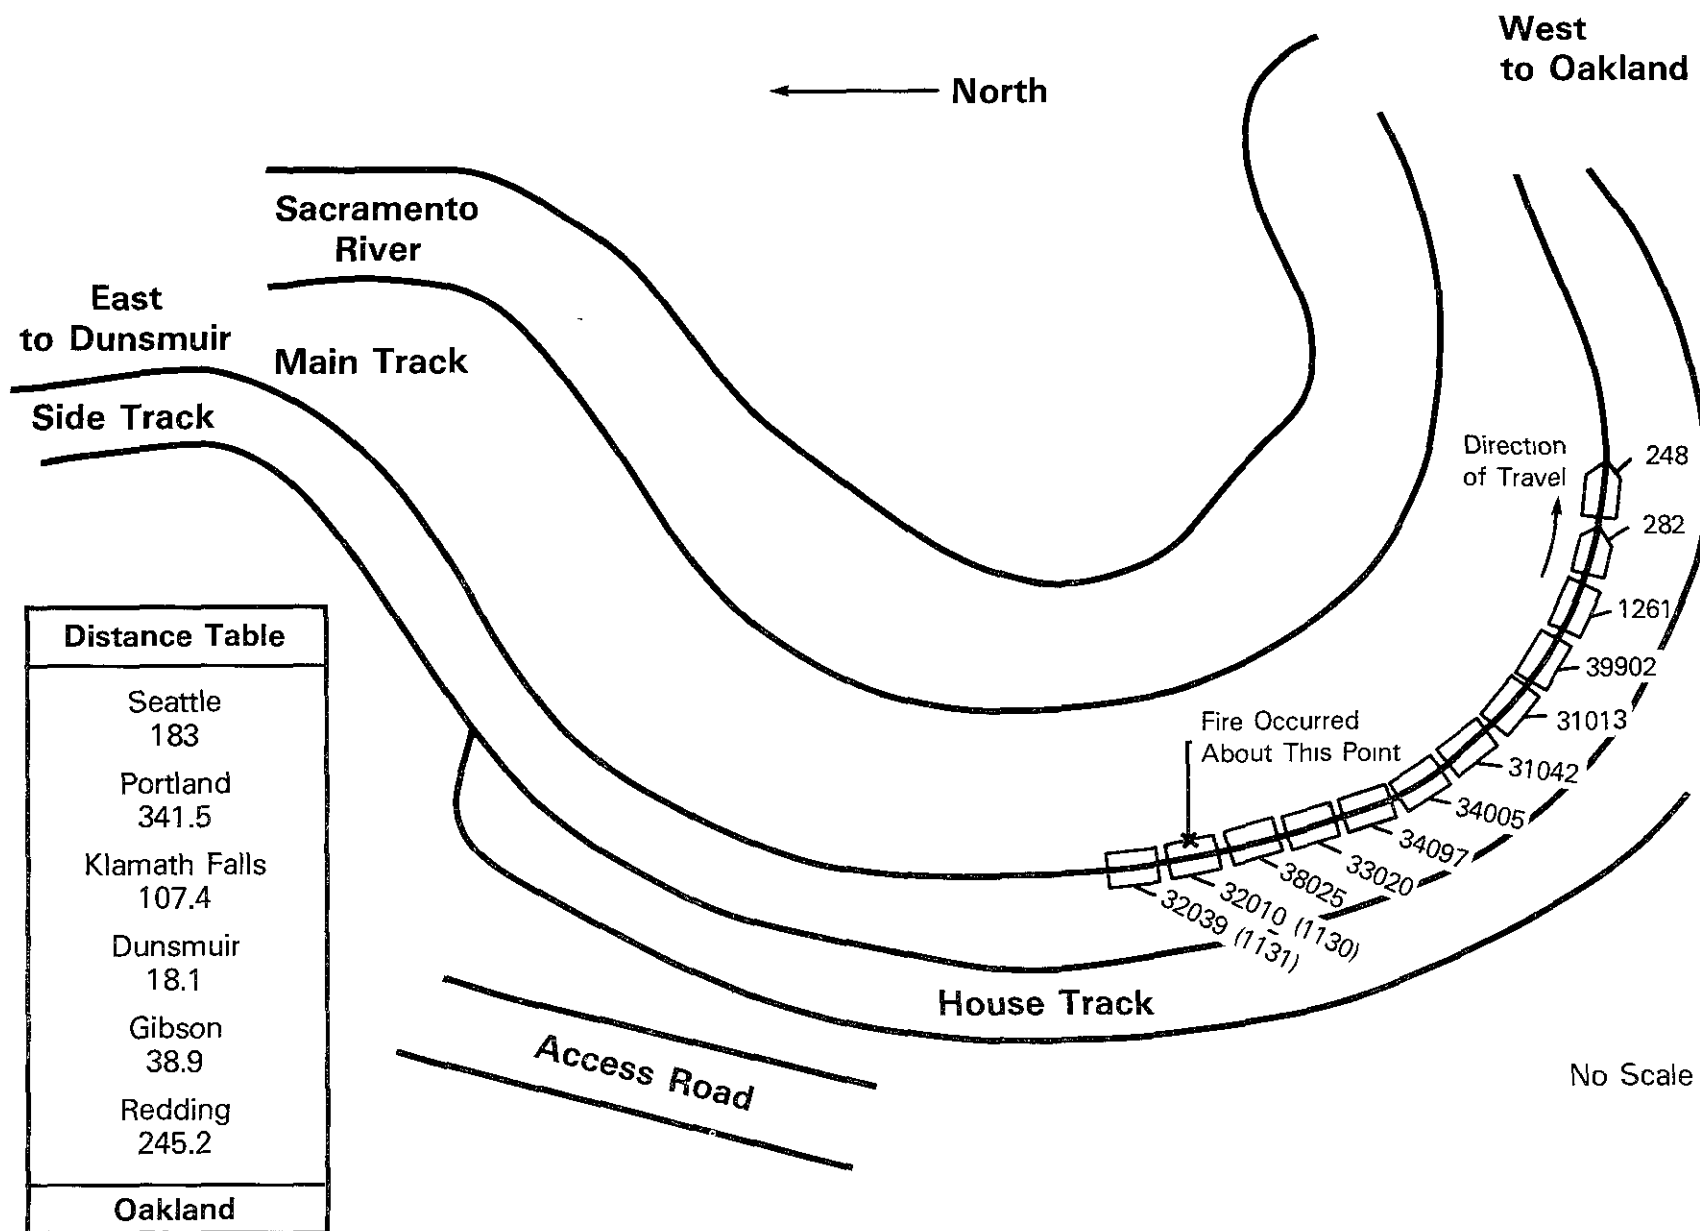
Figure 3.--Plan view of accident site.

The engineer said that he and the fireman looked northward at the train, which was standing in a left-hand curve in the direction of travel. (See figures 3 and 4.) They could see a yellowish light in the upper part of the 1130 car that was unlike the normal light reflected from a rail passenger car. When the engineer became aware of the magnitude of the fire, he radioed the dispatcher to send emergency fire assistance. Later, the conductor instructed him over the radio to make the moves required to separate the two rear cars in the train. The engineer said that he assigned the locomotive fireman the task of shutting off the electrical power to the train before the cars were uncoupled. The
